Plymouth
Britain's Ocean City

South Yard Area 5

Waterfront Development Strategy

March 2016

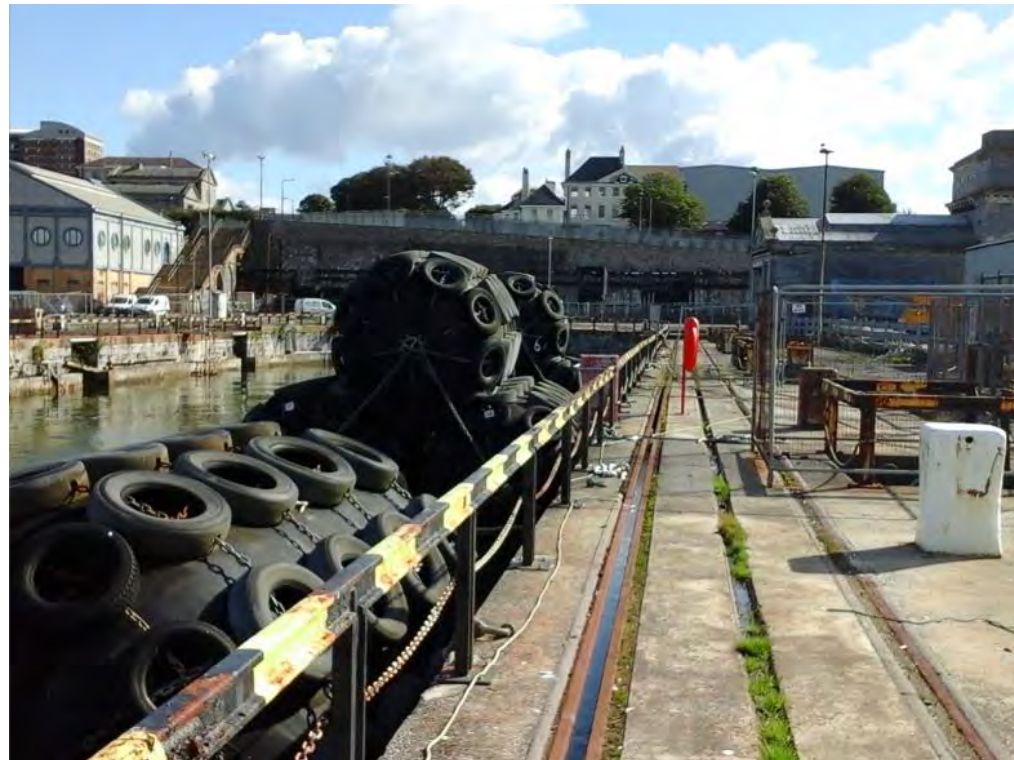
Crane rails run along the entire northern side of the dock approximately 0.5m from the quay edge. From Google Earth, it is apparent that these were operable in 2009.

The rails showed signs of deterioration with rusting and weeds present. The surrounding concrete appeared in a good condition.

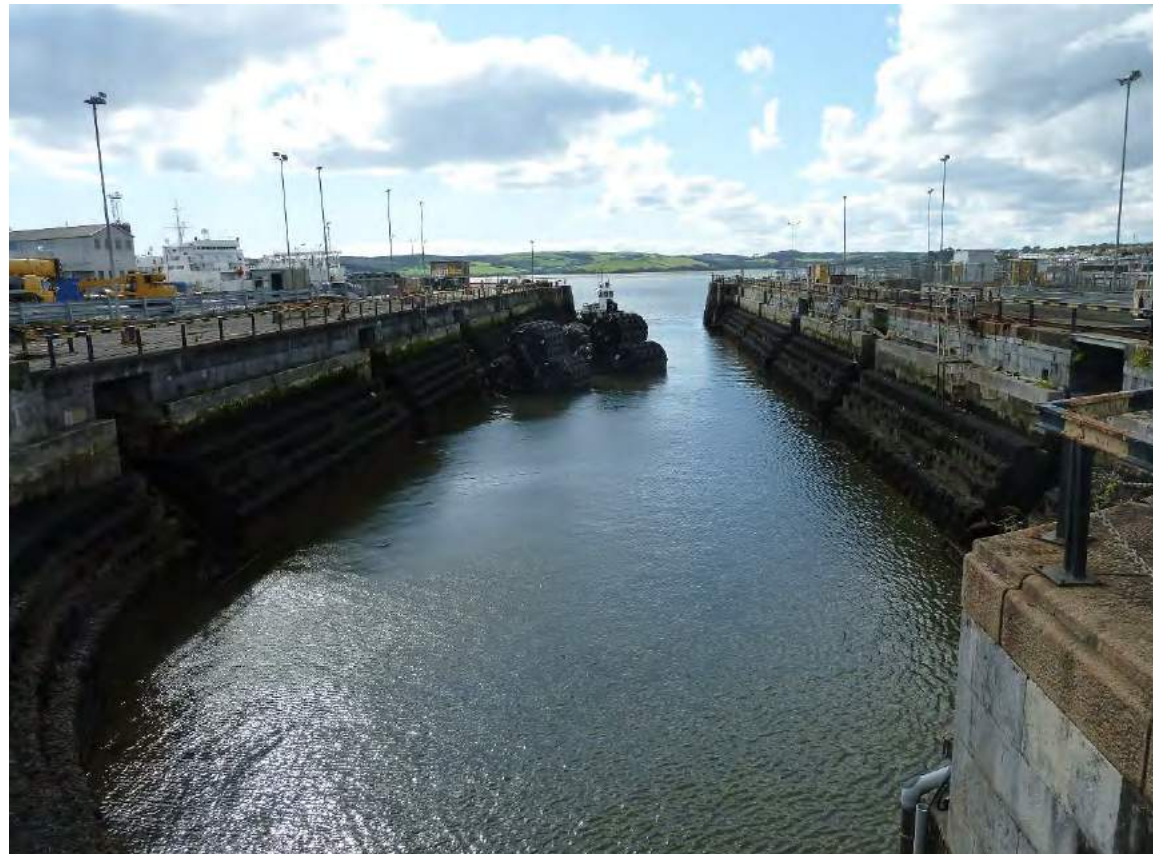
Overall the Ashlar blockwork appeared in a reasonable condition with some localised damage noted at the north wall dock entrance.

The jointing in the blockwork has been eroded over time, however no water seepage was observed.

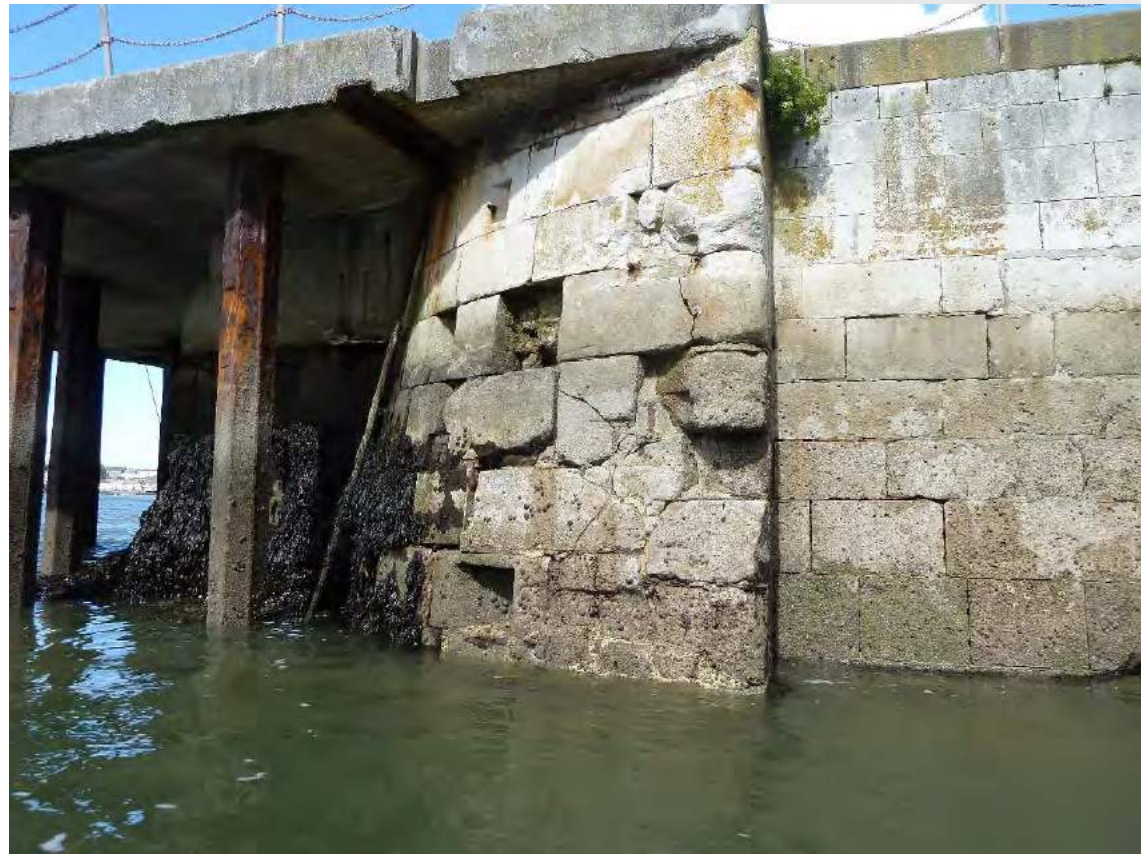
There was a note from an inspection in 2002 that there was evidence of efflorescence on the blockwork and that seawater was seen entering through the blockwork near the entrance. From further enquiries about the previous operations of the dock and water tightness of the structure, it is likely that this is a relatively small and contained problem that can be solved with local repair works.

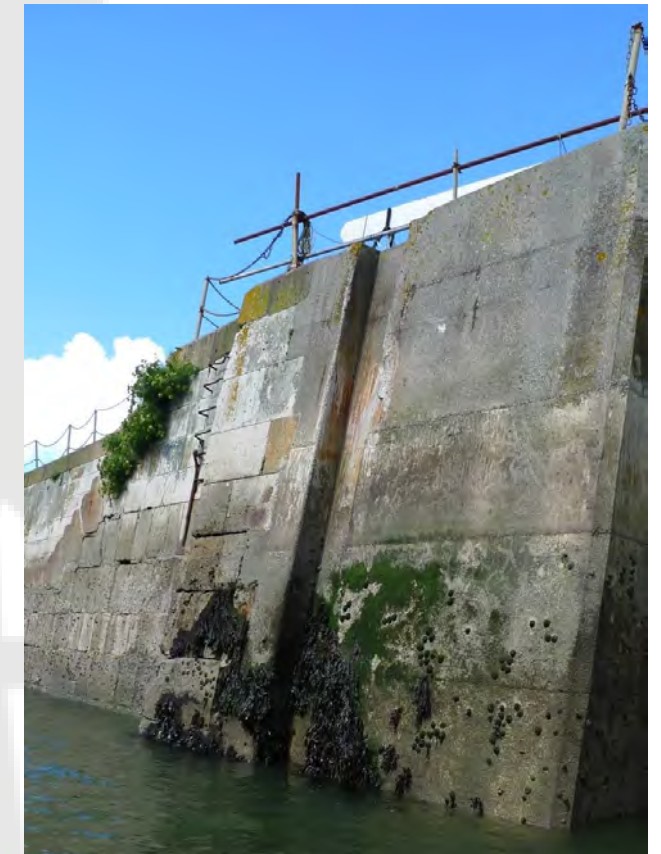
The recesses in the dock walls appeared in good condition, with only marine growth observed.

The dock ladder has heavily corroded and is not suitable for use.

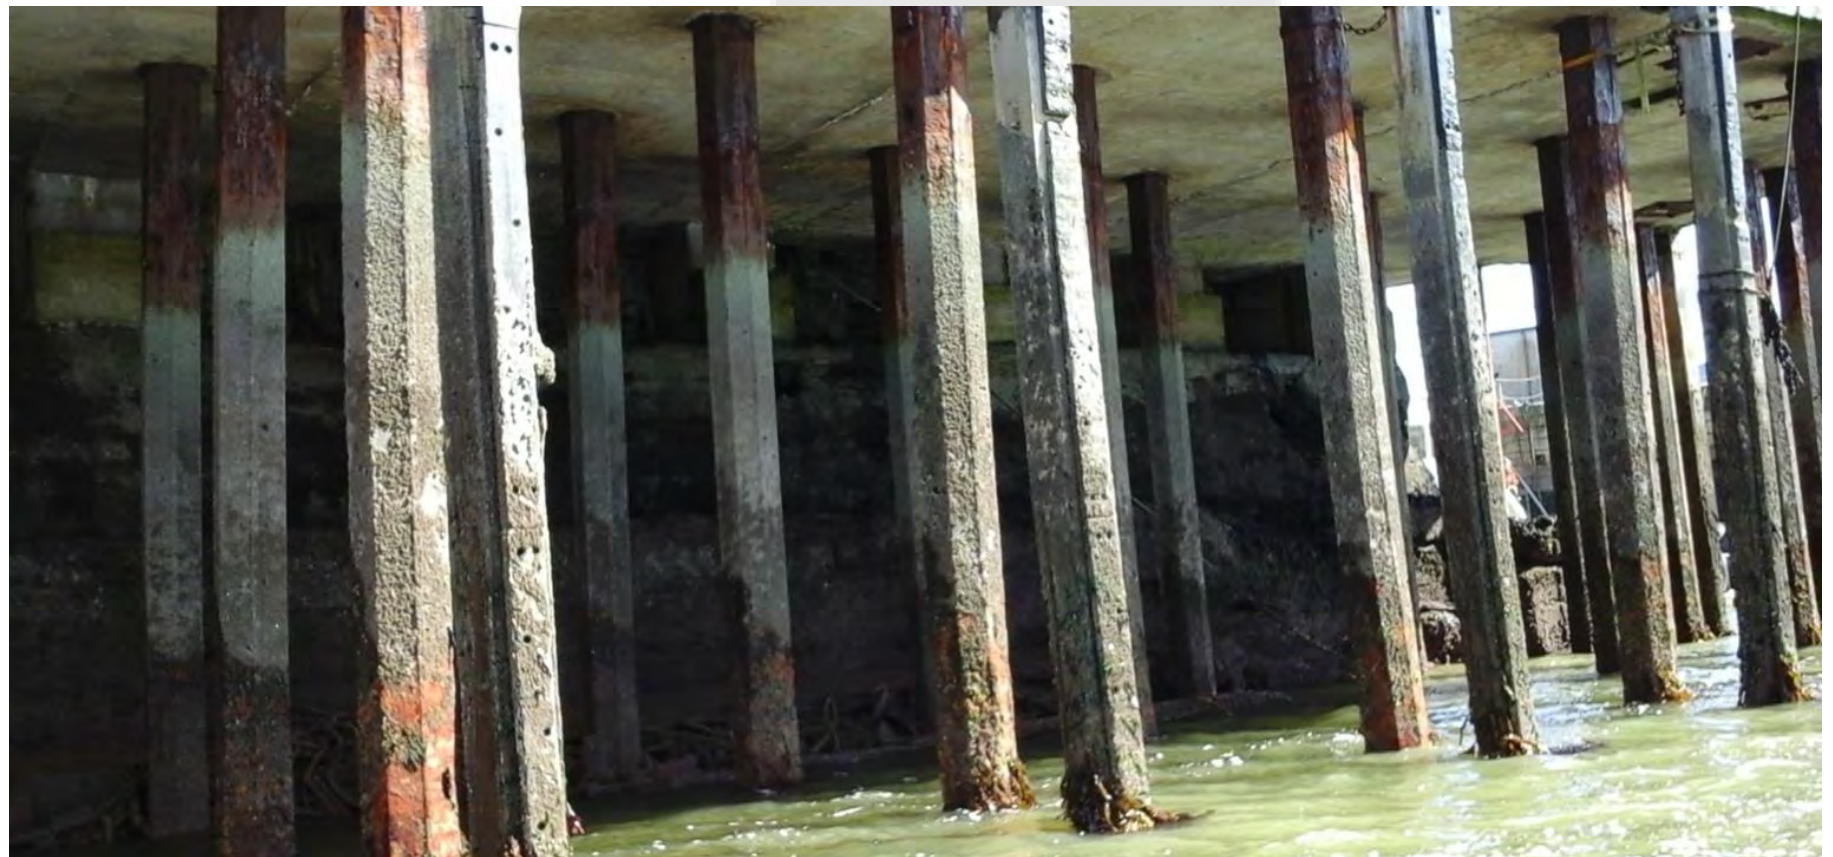
The Rendhex piles are in a poor condition, and at the low water mark the corrosion has extended to complete section loss of the pile. The previous URS 'Condition Survey of Docks and Jetties' (2014) report had identified that 21 piles had a thickness less than 10mm (original thickness 15-16mm).

Significant replace/repair works would be required to restore this jetty back to use.

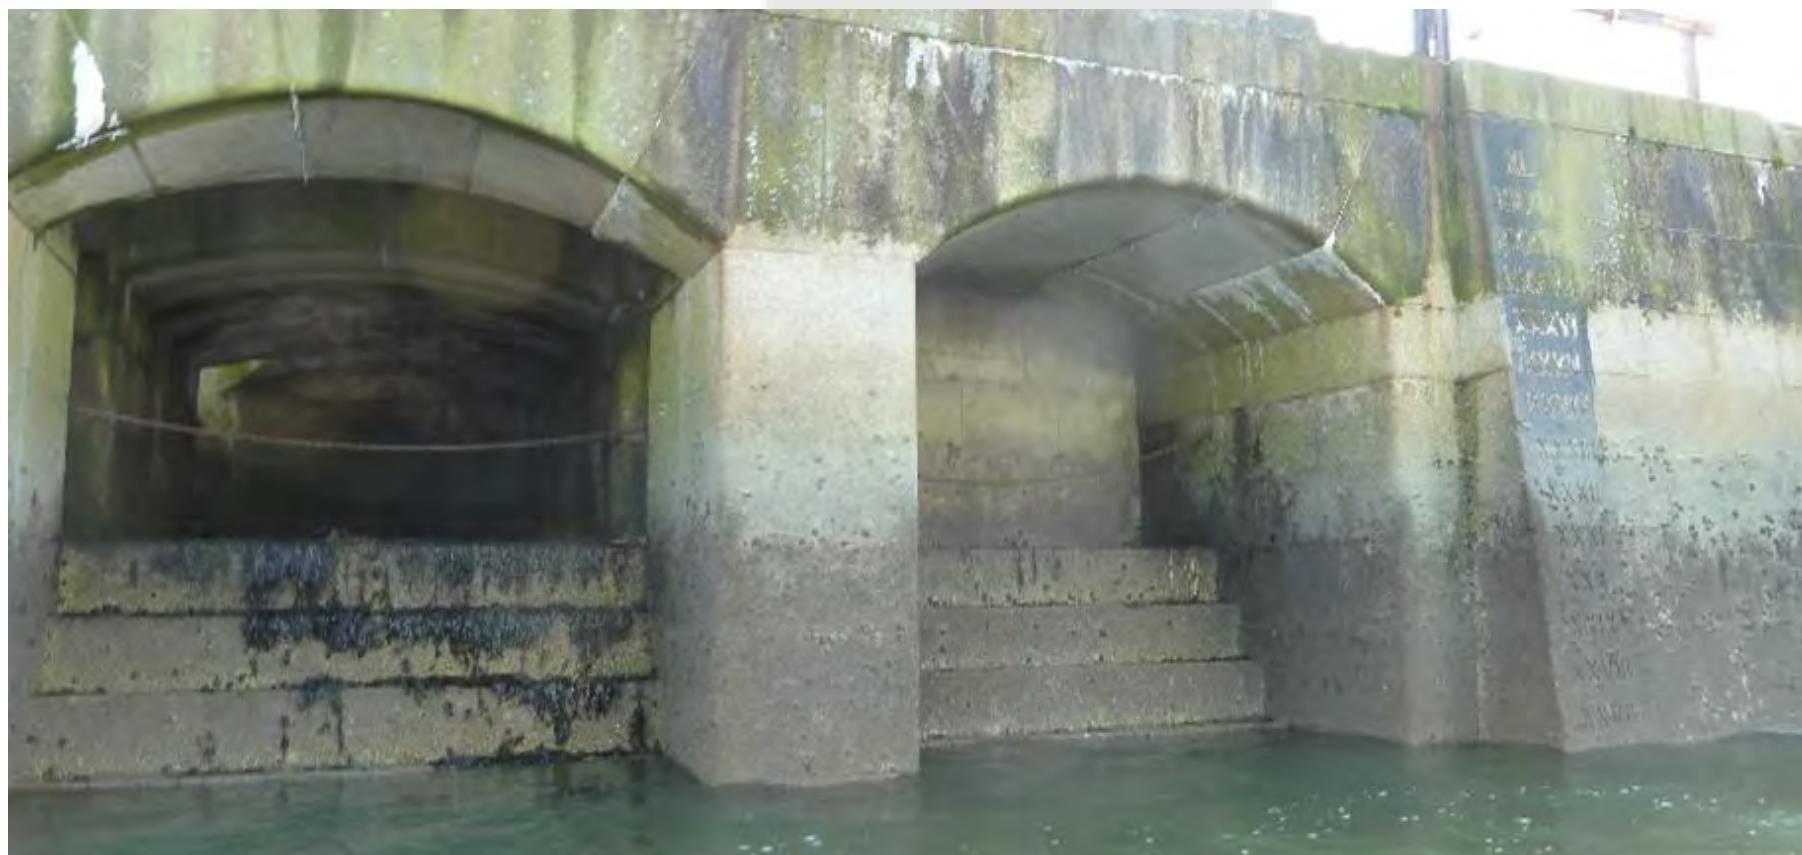
The above water elements of the dock appeared to be in a good condition. There are minor cracks in the blockwork and some water seepage was also recorded.

Water pouring from joints or cracks in the blockwork walls often results from 'tidal lag' where the free water level in the dock or sea has fallen more quickly than the water level within the structure. Any voids in the structure fill with water when the tide is high and act as a reservoir with water pouring out through any gaps. Minor repairs such as pointing and grouting can be used to reduce or eliminate this problem.

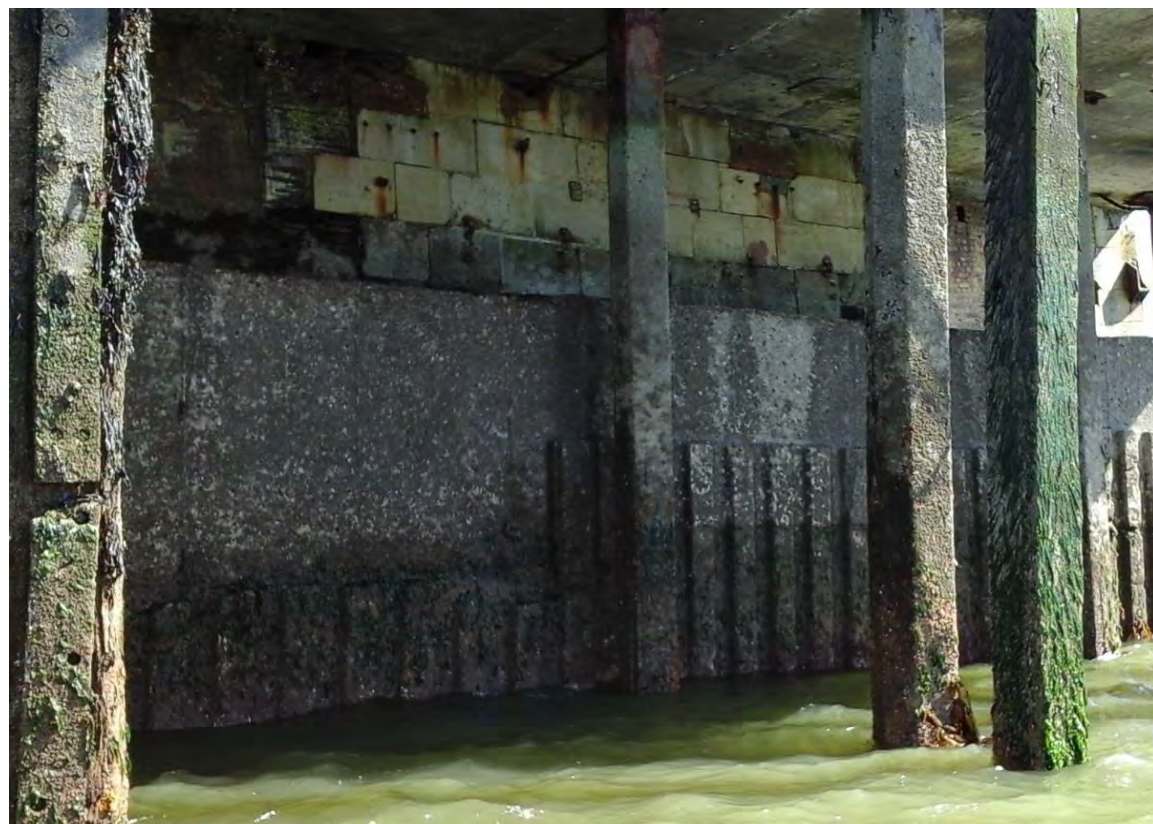
The original blockwork wall has suffered considerable deterioration, and the rear wall has been reinforced with a concrete buttress. Previous reports identified that there were no signs of significant deterioration or undermining of the concrete buttress.

The tops of the Rendhex piles have suffered from some corrosion and blistering. It has been suggested in previous records that zinc anodes may have been placed below the water line, but these were not visible during BR's inspection. The bright orange colouring of the piles at low water suggests that Microbiologically Influenced Corrosion (MIC) may be evident.

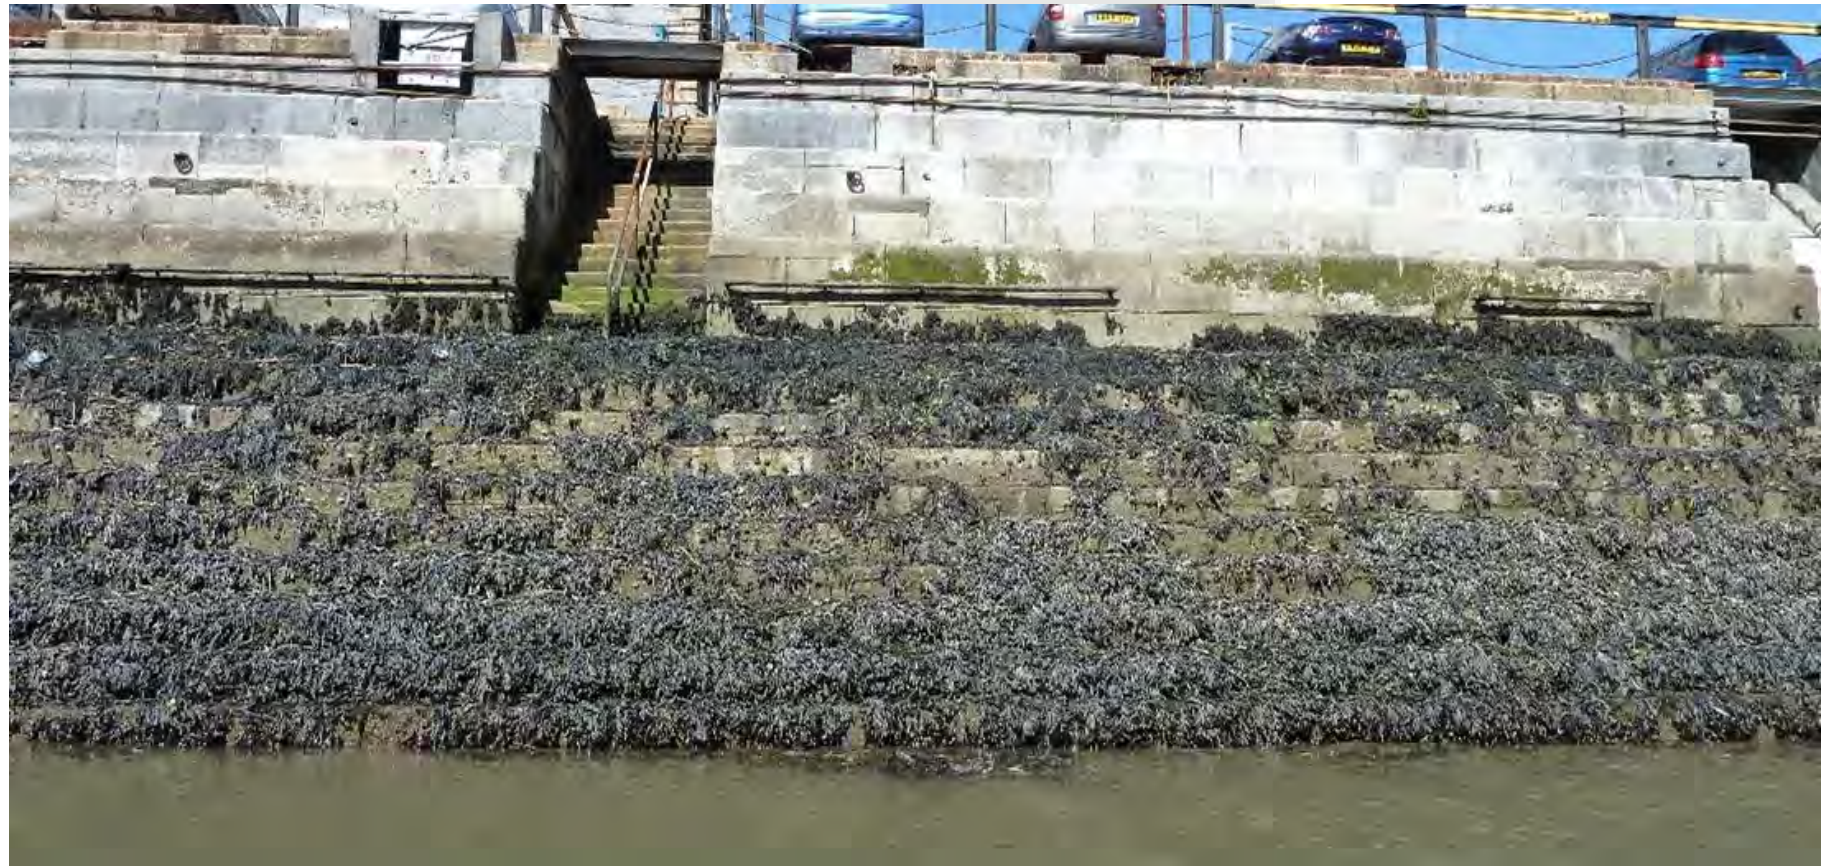
The blockwork appeared in generally good condition with only minor damage recorded. Some settlement was noted on the south wall of the dock and repairs were evident. There was apparent water seepage through the blockwork in some areas.

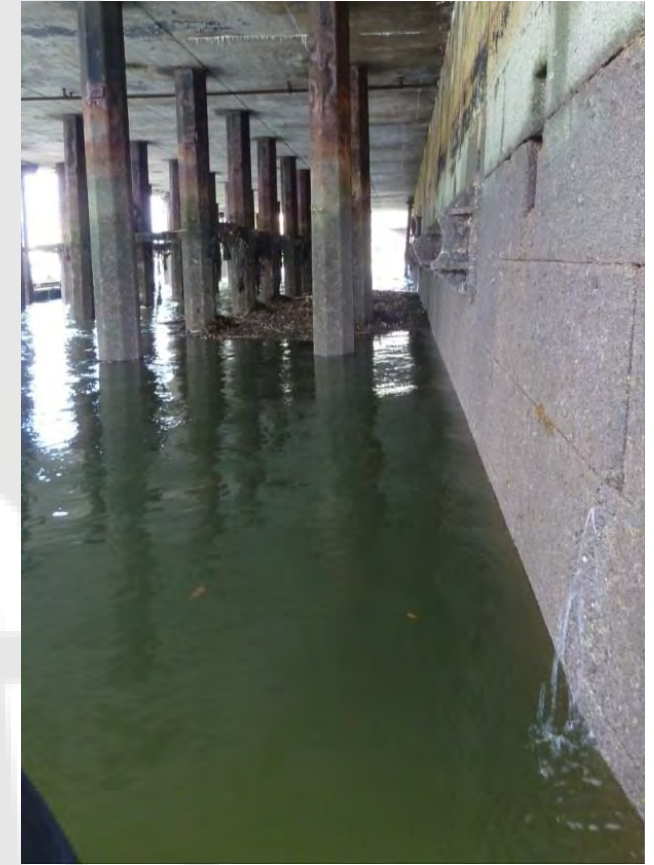
Corrosion was noted on the top of the piles. However, this appears to be less significant than the other jetties.

The timber fenders appeared to be in a good condition. The ladder on the jetty is not suitable for use and would require replacement.

It was observed that water was seeping through the blockwork wall. However, unlike the other jetties, no additional reinforced facing was identified, the blockwork appeared in a good condition.
