Plymouth
Britain's Ocean City

South Yard Area 5

Waterfront Development Strategy

March 2016

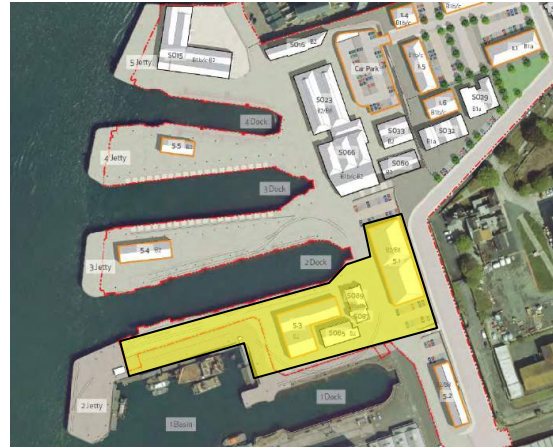
Quayside Area between Dock 1 and Dock 2

Crane rails run along the entire northern side of the dock approximately 0.5m from the quay edge. From Google Earth, it is apparent that these were operable in 2009.

The rails showed signs of deterioration with rusting and weeds present. The surrounding concrete appeared in a good condition.

The guard rails around the access areas had rust staining, and the base plates were heavily corroded.

General Condition - No significant deterioration was noted. Some rutting in the tarmac was recorded. Quayside handrailing was present but requires replacing to meet safety regulations.

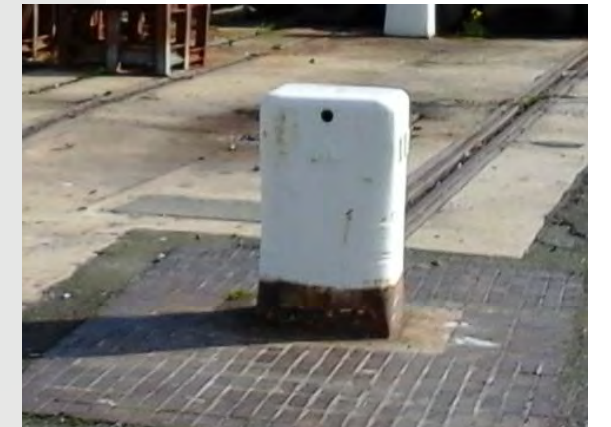
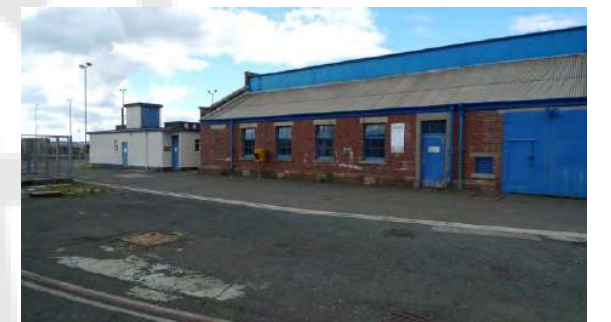
A number of VR (Victoria Regina) historic bollards were seen, and although some rust staining was visible, the bollards appeared to be in sound condition.

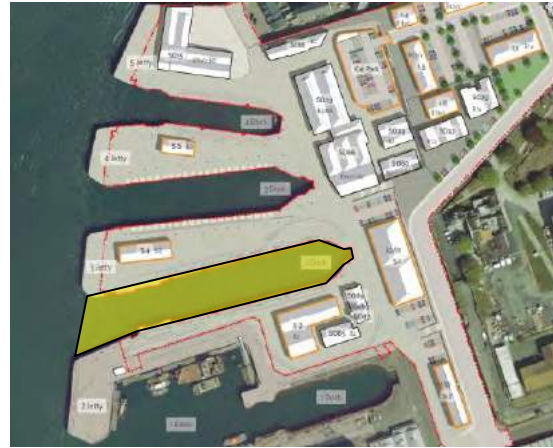
Dock 2 is the largest of the docks. The structure is a traditional dock outline with stepped access on either side. A number of disused services run the length of the dock.

Overall the Ashlar blockwork appeared in a reasonable condition with some localised damage noted at the north wall dock entrance.

The jointing in the blockwork has been eroded over time, however no water seepage was observed.

There was a note from an inspection in 2002 that there was evidence of efflorescence on the blockwork and that seawater was seen entering through the blockwork near the entrance. From further enquiries about the previous operations of the dock and water tightness of the structure, it is likely that this is a relatively small and contained problem that can be solved with local repair works.

The recesses in the dock walls appeared in good condition, with only marine growth observed.

The dock ladder has heavily corroded and is not suitable for use.

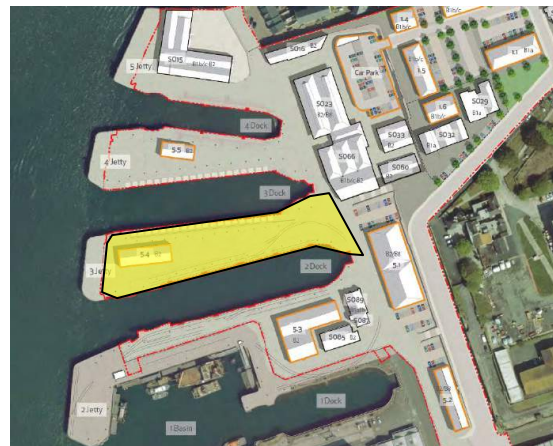
Quayside Area between Dock 2 and Dock 3

This Quayside does not have existing buildings. Crane rails are present serving both sides of the quay, with some parts of the rails having been removed.

A flood valve is located on the western end of the quay just before No. 3 Jetty, this would have been used to flood the dock when required.

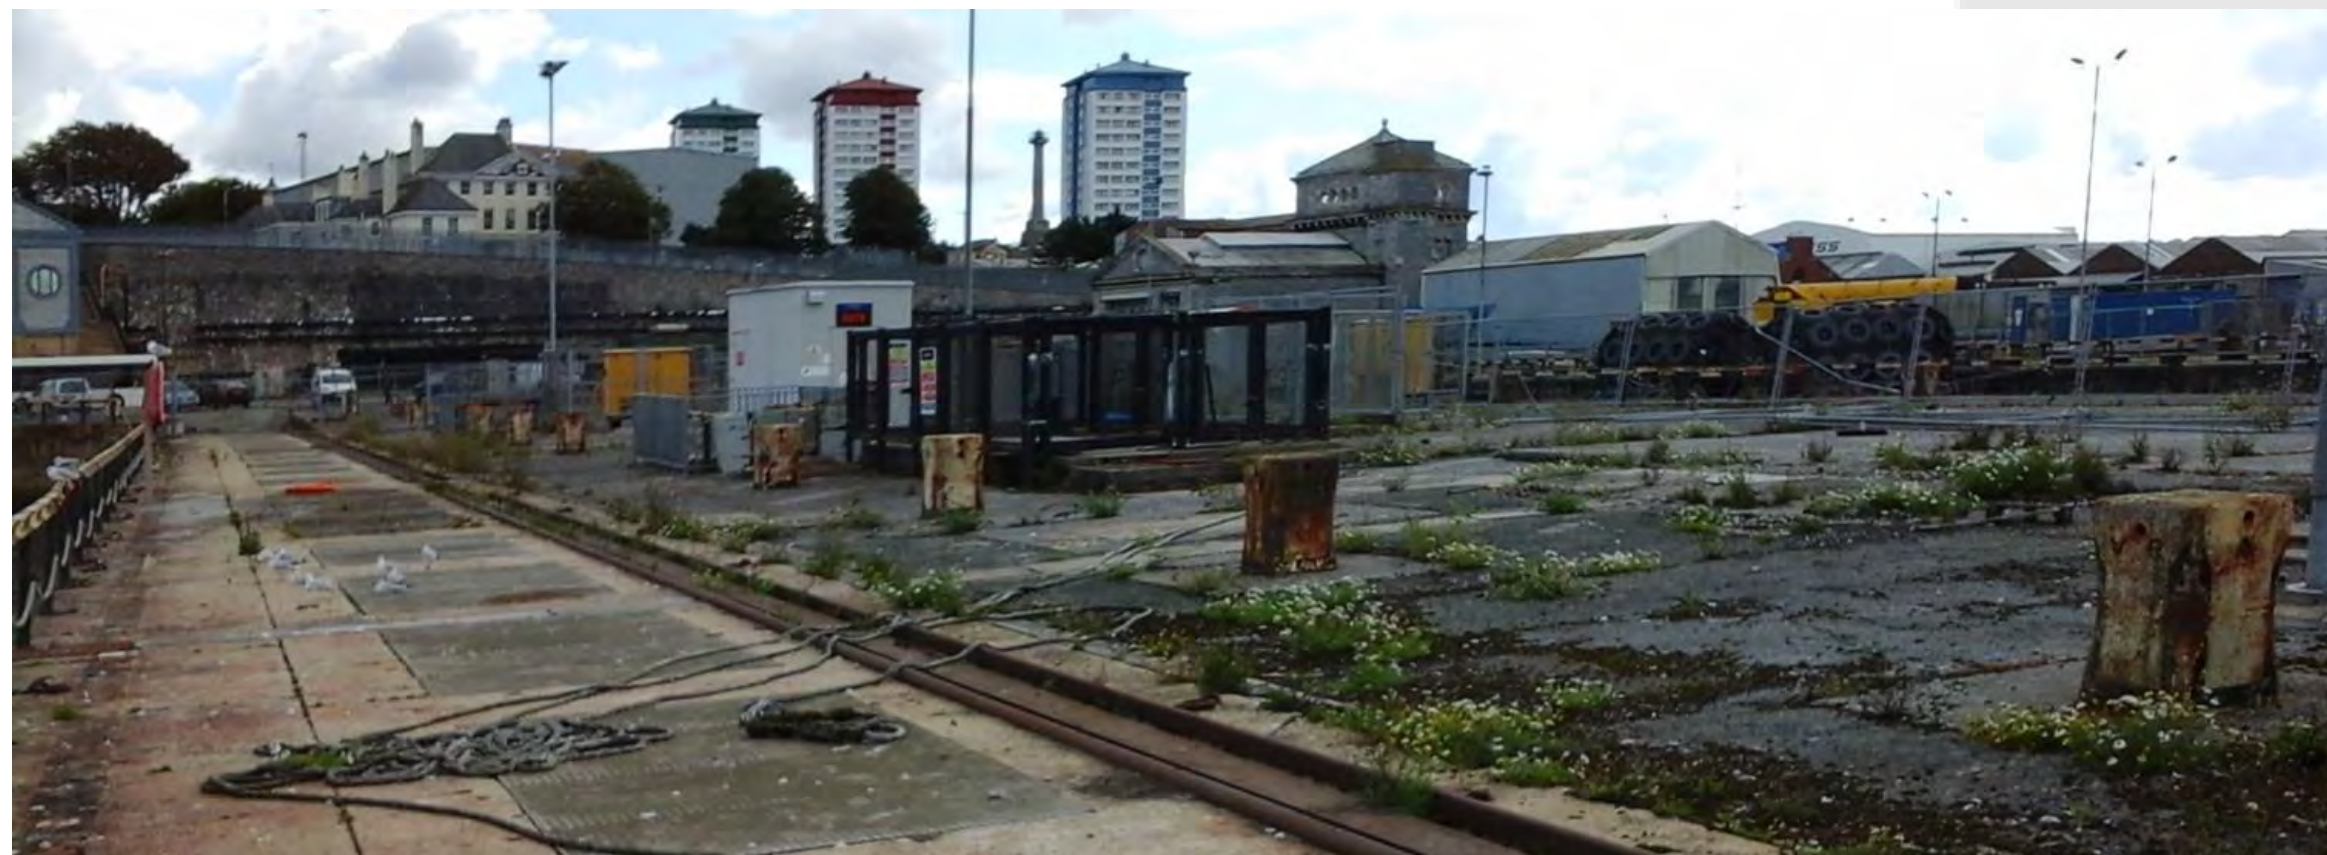
From previous MoDs inspections of the jetty, it was noted by Unicorn in 2000 that an area of approximately 3m2 of tarmac “had sunk 200-300mm” on the jetty.

It is recommended in the report that this area should be re-tarmacked. The URS ‘Condition Survey of Docks and Jetties’ (2014) identified that a later inspection (2002) revealed that this repair had not been carried and requested that further investigation should be sought before remedial works are carried out.

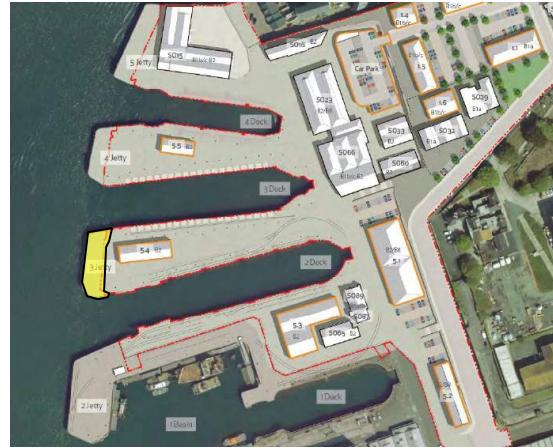
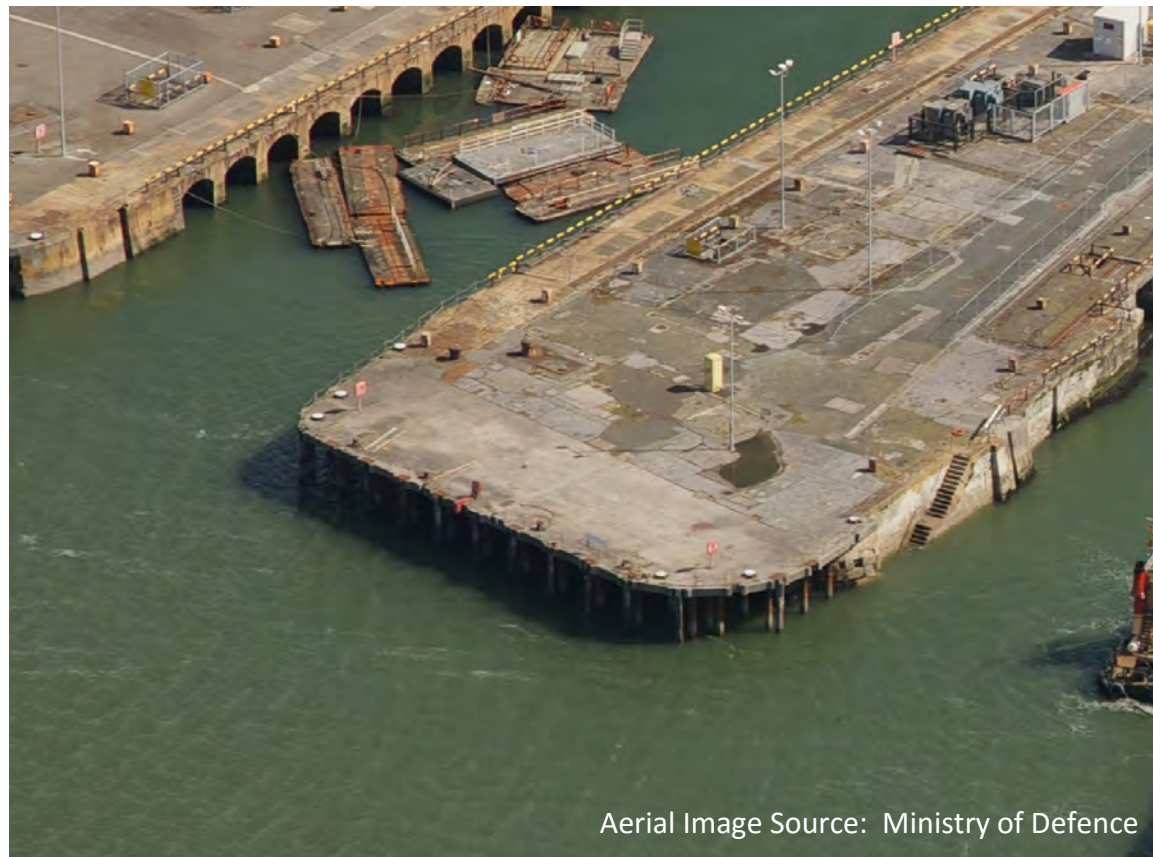
Recessed wooden timbers with a UHMW-PE facing forms part of the fendering protection to the jetty. Square fenders connect the tops of the piles to the deck of the jetty.

The timber fenders appear in a good condition, and previous reports have suggested that these were replaced in 1995. Some of the UHMW-PE facings are missing.

The Rendhex piles are in a poor condition, and at the low water mark the corrosion has extended to complete section loss of the pile. The previous URS 'Condition Survey of Docks and Jetties' (2014) report had identified that 21 piles had a thickness less than 10mm (original thickness 15-16mm).

Significant replace/repair works would be required to restore this jetty back to use.

Jetty 3 is in a very poor condition, a decision is required whether to demolish or re-build the entire structure. As quayside and berthing space is a valuable commodity to any working dock area, it is anticipated that this will be re-built. To establish design parameters, boreholes should be undertaken. Cost £20,000 - £50,000 assuming 3 boreholes driven through concrete deck, rather than using marine plant.

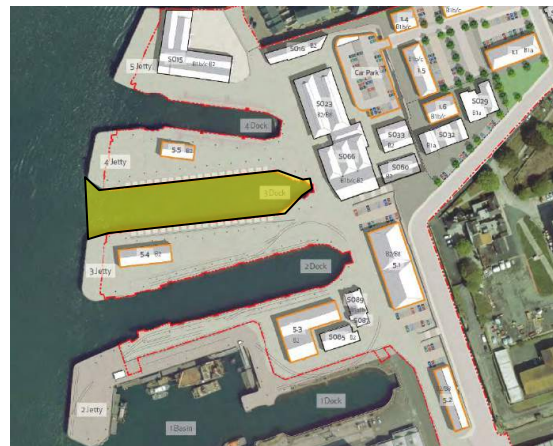
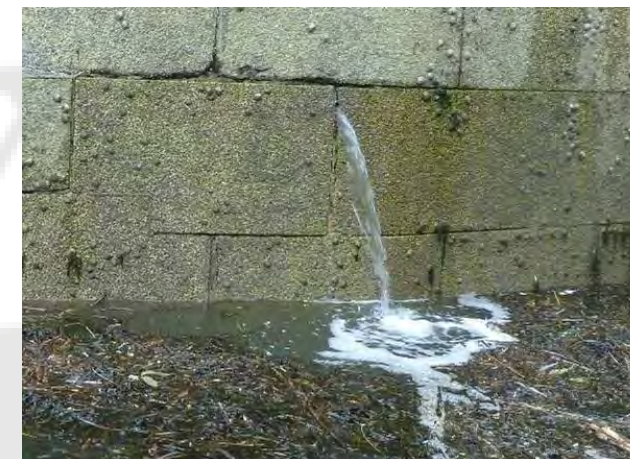
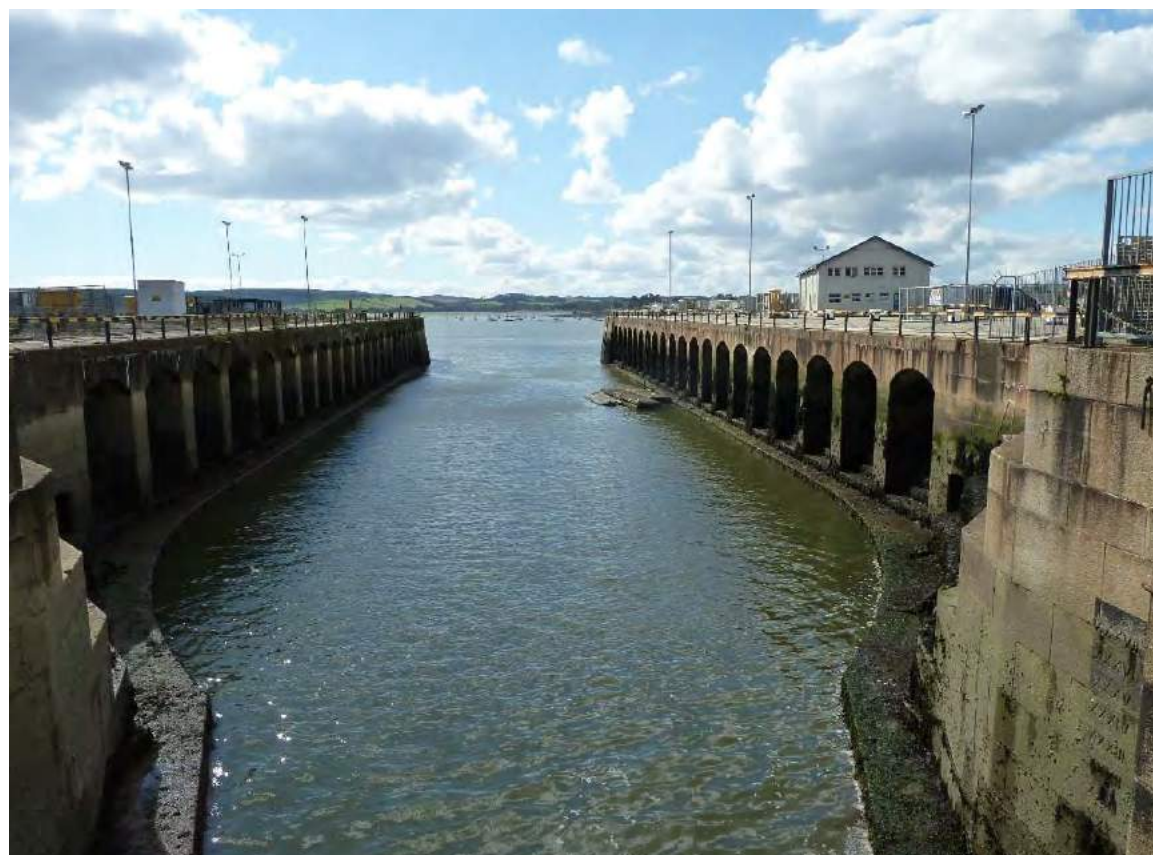
Dock 3 is the most architecturally advanced of these structures. The dock has a unique access configuration whereby stairways lead to granite arches that allow for vertical sides to the dock.

The old caisson gate slotted into a formed sloped recess to allow the dock to be dewatered.

The above water elements of the dock appeared to be in a good condition. There are minor cracks in the blockwork and some water seepage was also recorded.

Water pouring from joints or cracks in the blockwork walls often results from 'tidal lag' where the free water level in the dock or sea has fallen more quickly than the water level within the structure. Any voids in the structure fill with water when the tide is high and act as a reservoir with water pouring out through any gaps. Minor repairs such as pointing and grouting can be used to reduce or eliminate this problem.

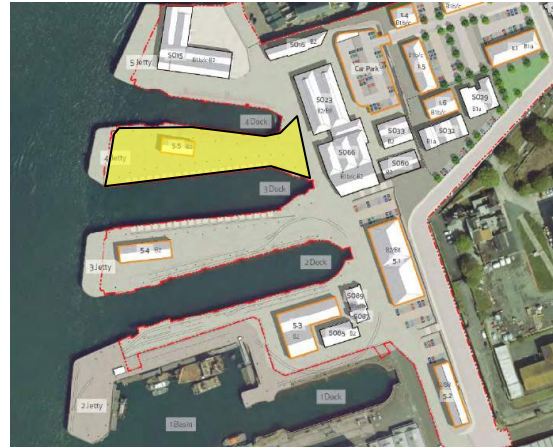
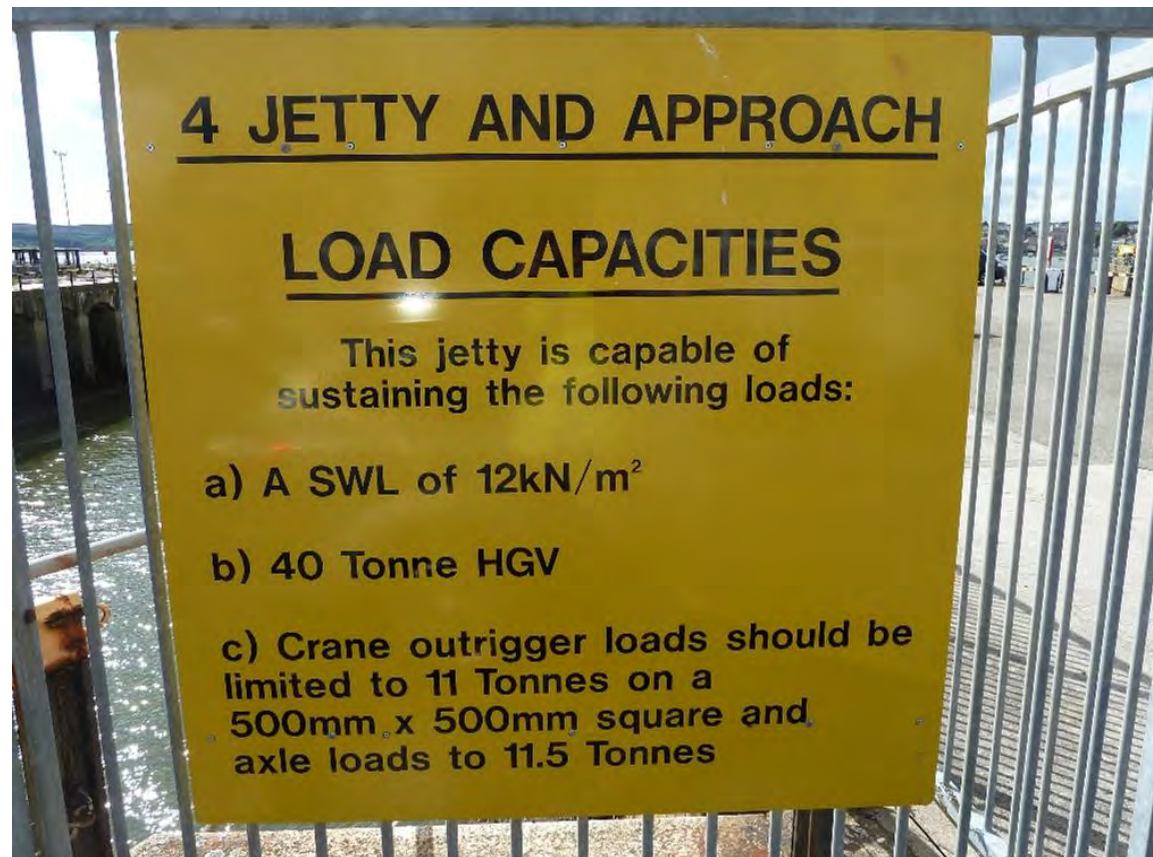
Quayside Area between Dock 3 and Dock 4

The entrance to the quayside area is gated and is currently used as a car parking area. The quay appears to have been resurfaced and the VR bollards have been repainted to restore them back to their original condition.

A sign attached to the quay boundary fence identifies permissible loads on the quay. Following discussions with Babcock Marine, it is unknown when this assessment was done but it has been highlighted that it was not recent and, therefore, does not account for any deterioration noted.

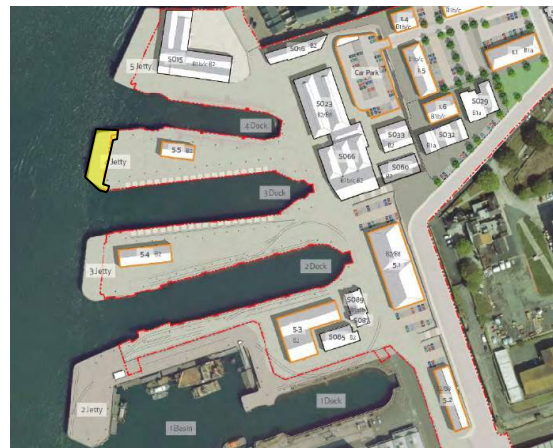
Jetty 4

Similar to Jetty 3, this jetty is formed from a 600mm suspended reinforced concrete slab supported by Rendhex piles.

Timber fenders with a UHMW-PE facing are positioned within recesses in the concrete slab.

The original blockwork wall has suffered considerable deterioration, and the rear wall has been reinforced with a concrete buttress. Previous reports identified that there were no signs of significant deterioration or undermining of the concrete buttress.

The tops of the Rendhex piles have suffered from some corrosion and blistering. It has been suggested in previous records that zinc anodes may have been placed below the water line, but these were not visible during BR's inspection. The bright orange colouring of the piles at low water suggests that Microbiologically Influenced Corrosion (MIC) may be evident.

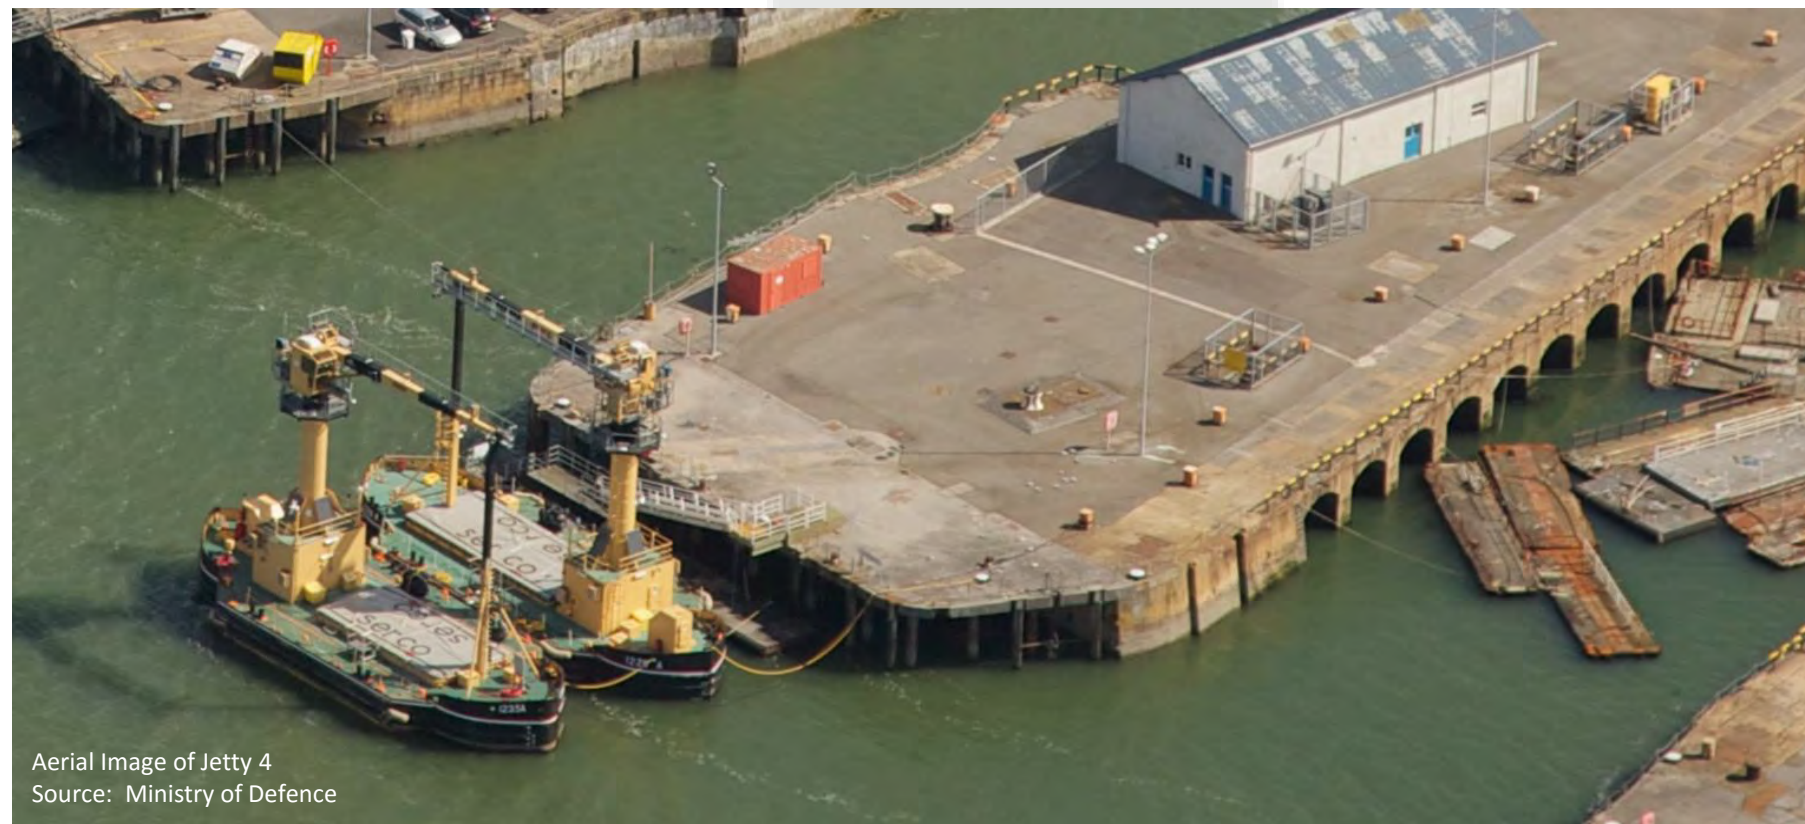
Aerial Image of Jetty 4
Source: Ministry of Defence

From the previous URS report 'Condition Survey of Docks and Jetties' (2014), it was noted that a fixed brow and floating pontoon structure was present. During the BR survey, the brow and pontoon were no longer in place, but the fixed cantilevered steel bankseat remains. The bankseat is anchored through the concrete deck.

The load capacity of the jetty was highlighted on a yellow sign. However, following discussions with Babcock Marine it is unknown when this assessment was done but it has been highlighted that it was not recent and did not account for the deterioration noted in the steel piles. It is envisaged that the load capacity will be reduced due to the deterioration of the jetty.

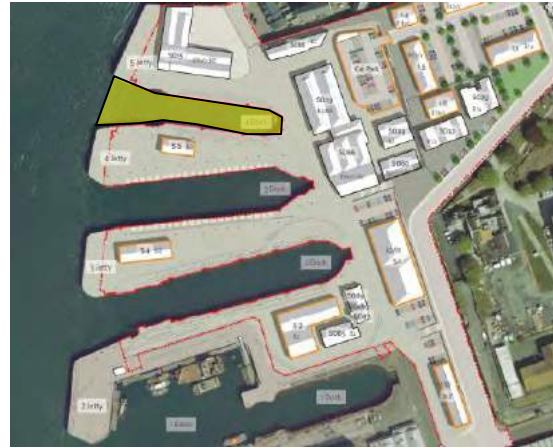
Dock 4 is the smallest basin of the three docks approximately measuring 30m wide by 85m long with depths of only 4.65m to the keel blocks at MHWS. The dock outline is similar to Dock 2 with stepped access from both sides.

The dock is relatively shallow and during low spring tides the silt is exposed at the head of the dock. Heavy marine growth was observed below the high water mark.

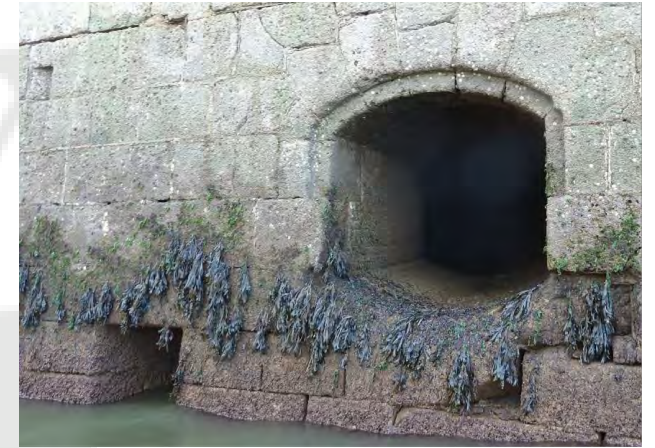
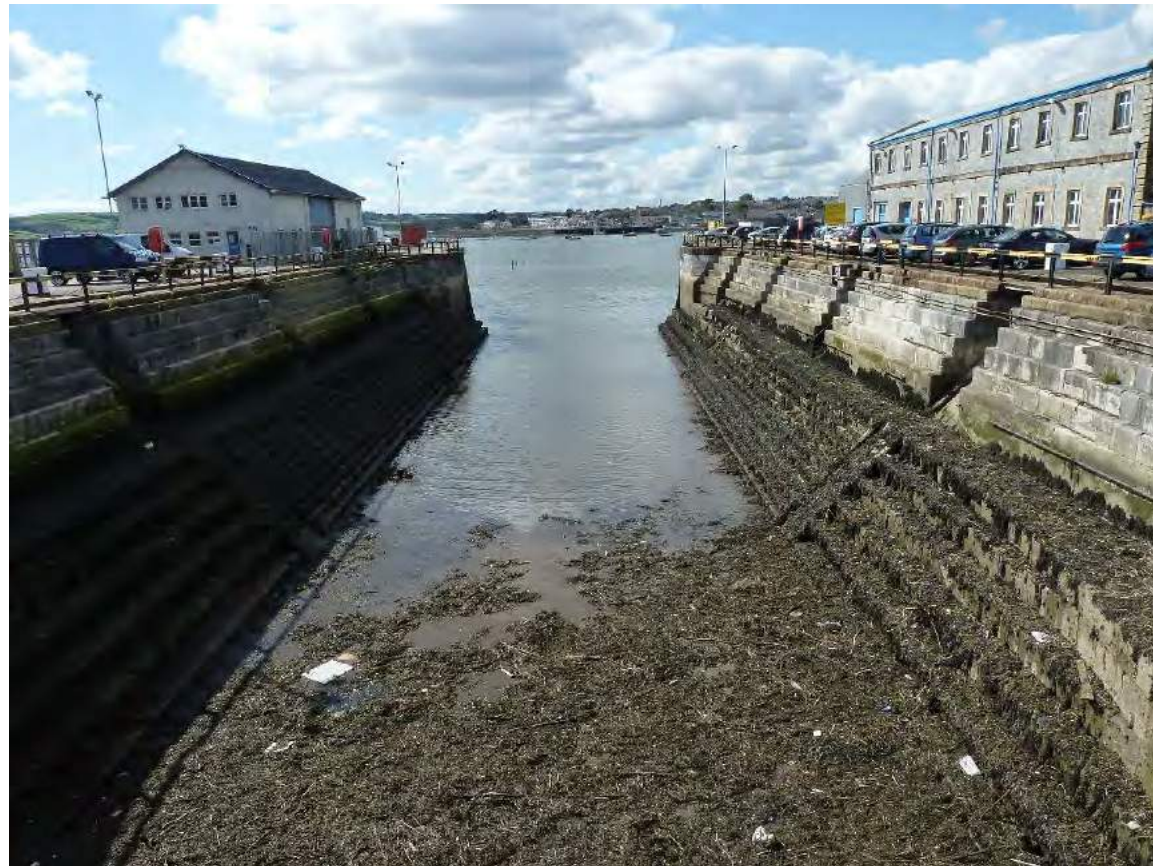
The URS 'Condition Survey of Docks and Jetties' (2014) notes that record drawings indicate that a masonry sill with a timber facing is provided at the entrance.

From record drawings, it is also known that the dock previously had a set of iron gates rather than a floating caisson as used for the other docks. These gates were removed in the 1990s, and the dock was left as a tidal dock.

The blockwork appeared in generally good condition with only minor damage recorded. Some settlement was noted on the south wall of the dock and repairs were evident. There was apparent water seepage through the blockwork in some areas.

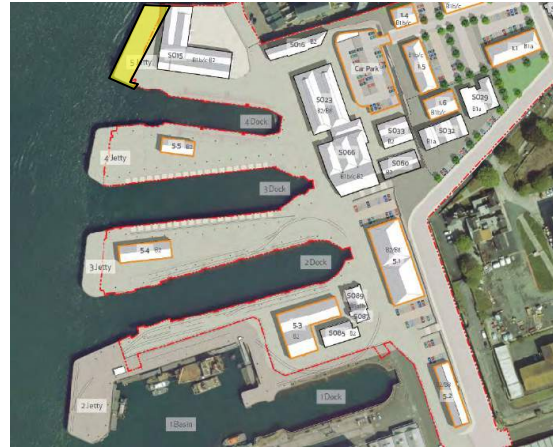
Jetty 5 was constructed with a 840mm concrete suspended deck supported by Rendhex piles. The jetty approximately measures 12m wide by 54m long.

Timber fenders with a UHMW-PE facing are positioned within recesses in the concrete slab. Signage on the approach identify the outdated loading restrictions on the jetty, which requires a new assessment to take into account the condition of the piles.

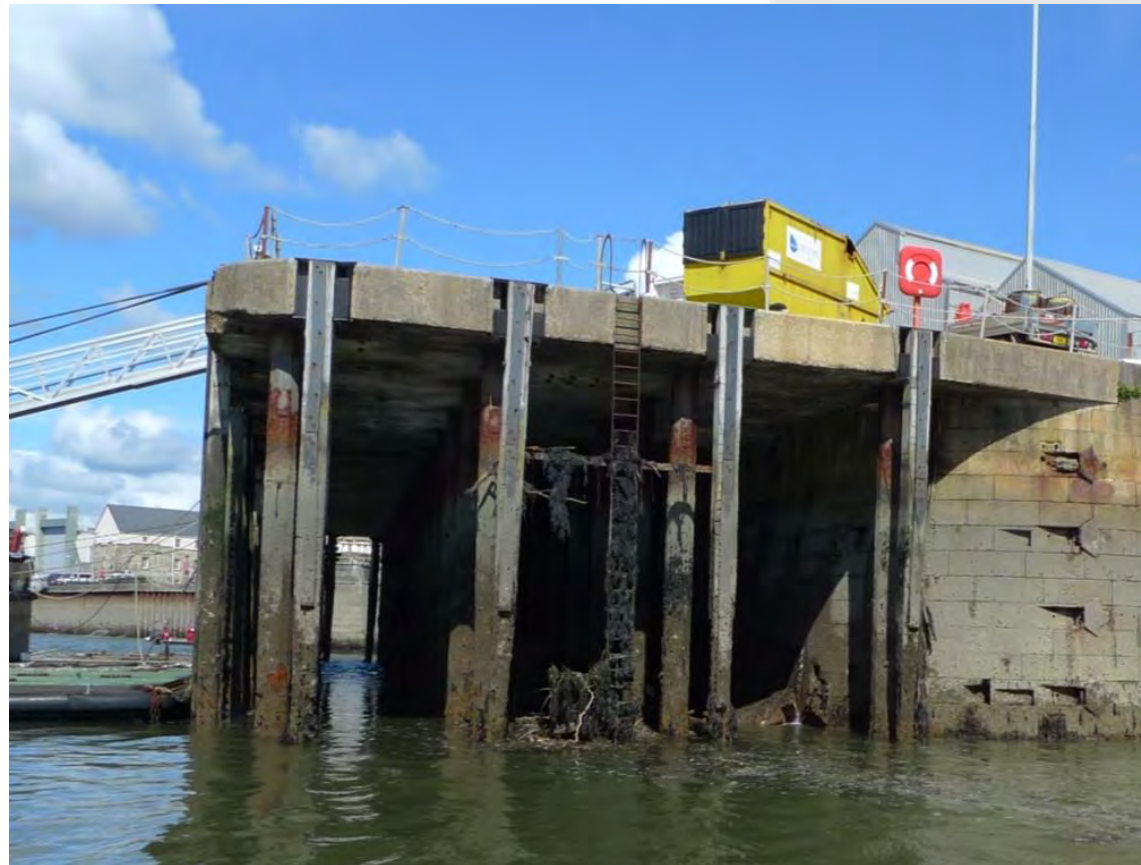
Corrosion was noted on the top of the piles. However, this appears to be less significant than the other jetties.

In the URS 'Condition Survey of Docks and Jetties' (2014) it was noted that the piles were painted in 1994 and that some paint remained on the piles in 2014.

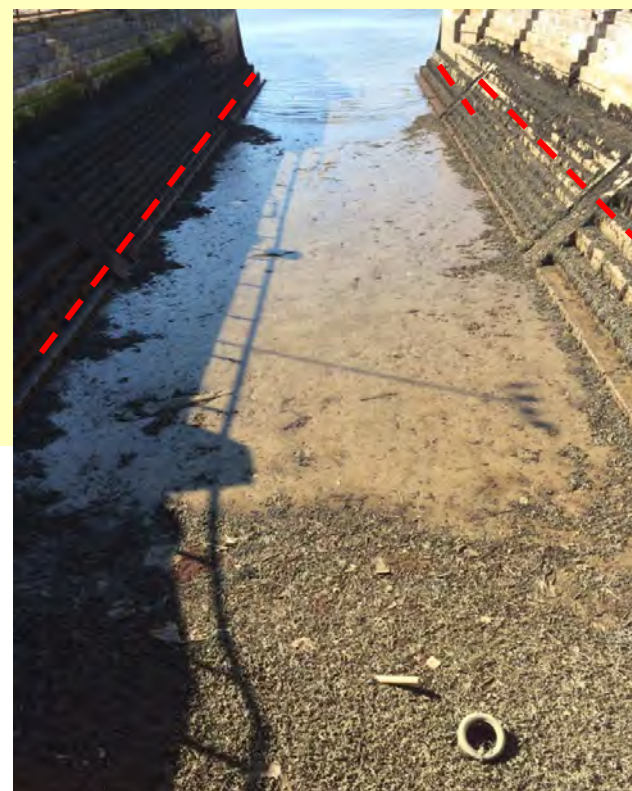
Sections A-A and B-B identify the amount of silt in comparison to the outline of the dock. These show that depth of silt is approximately 1500mm suggesting a 75mm accretion rate per year. The results also show that silt appears to have accumulated on one side of the dock; however a photograph provided this year shows that the level of silt appears to be evenly spread. This may highlight some possible inaccuracies with the bathymetric data.

-- Level of silt suggested in the bathymetry survey

Photo of Dock 4 during low spring tide showing silt level
Source: PCC

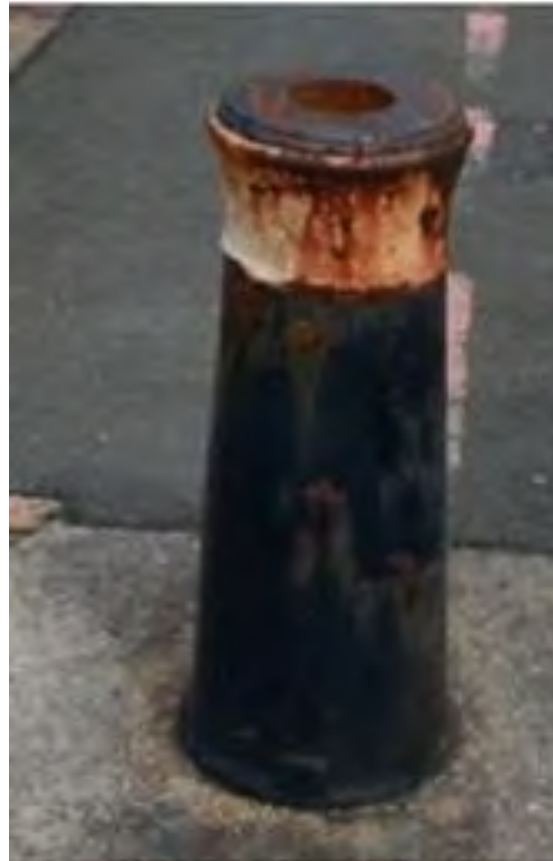
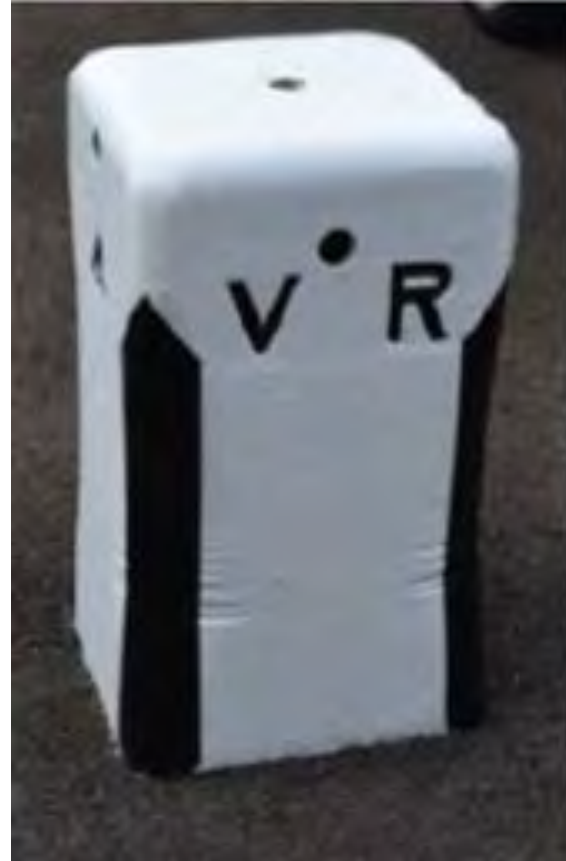
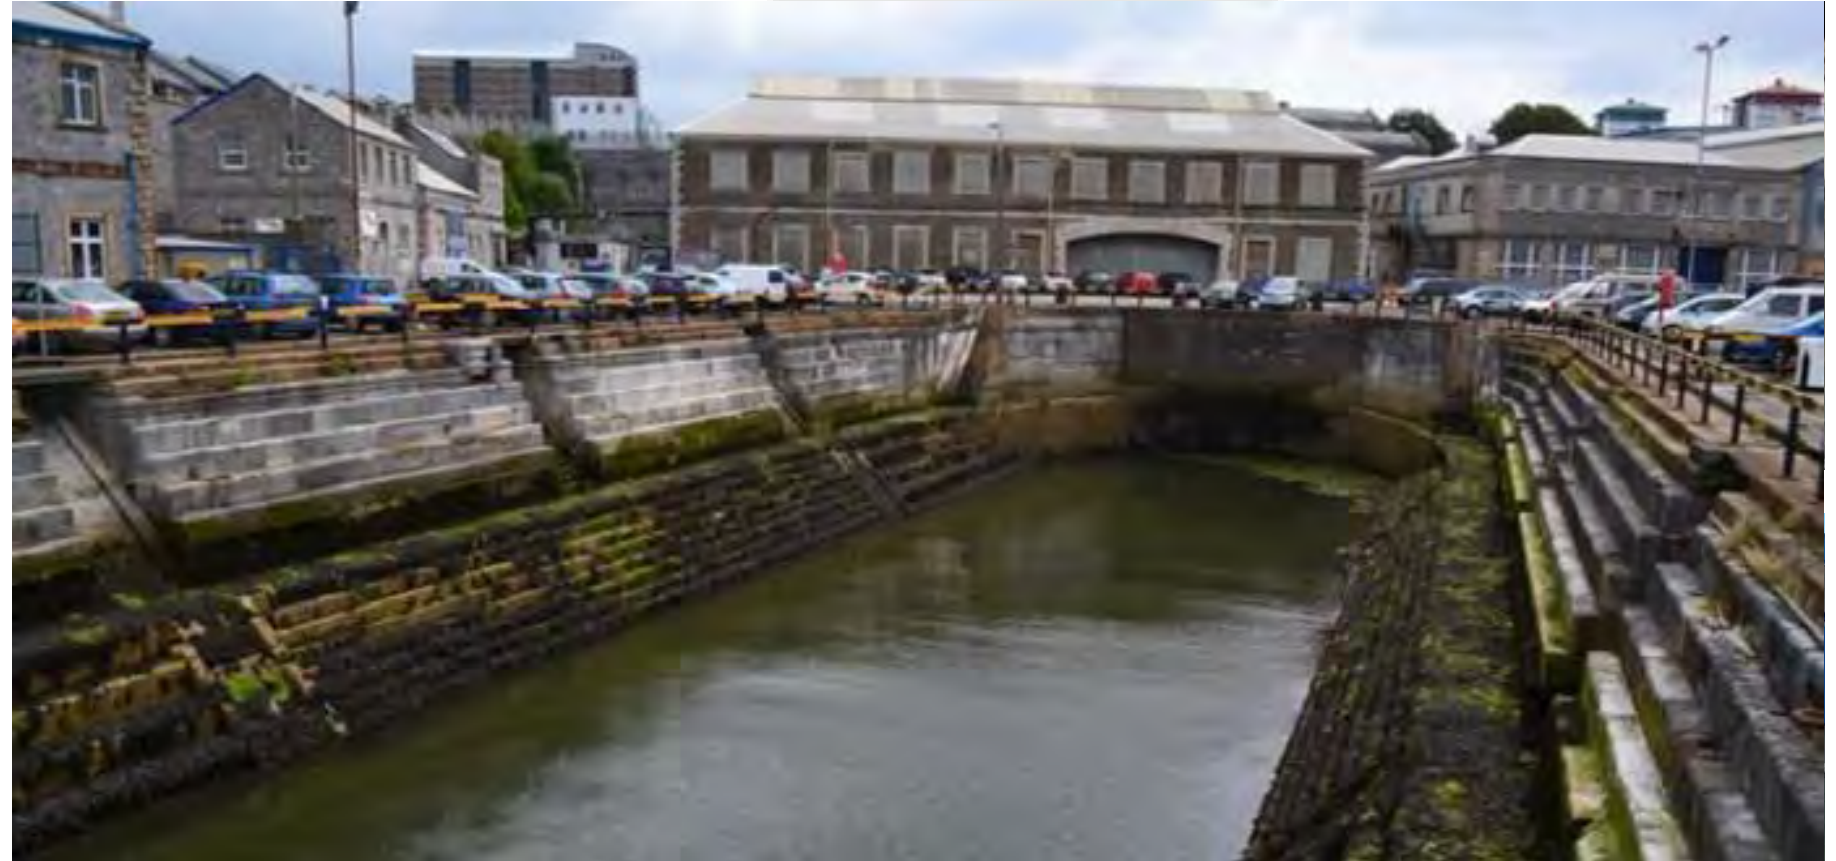
Significance: Exceptional

A number of VR (Victoria Regina) historic bollards were present and although some rust staining was present they appear to be in sound condition.

Rusty Bollards: Clean and repaint. Cost £500.

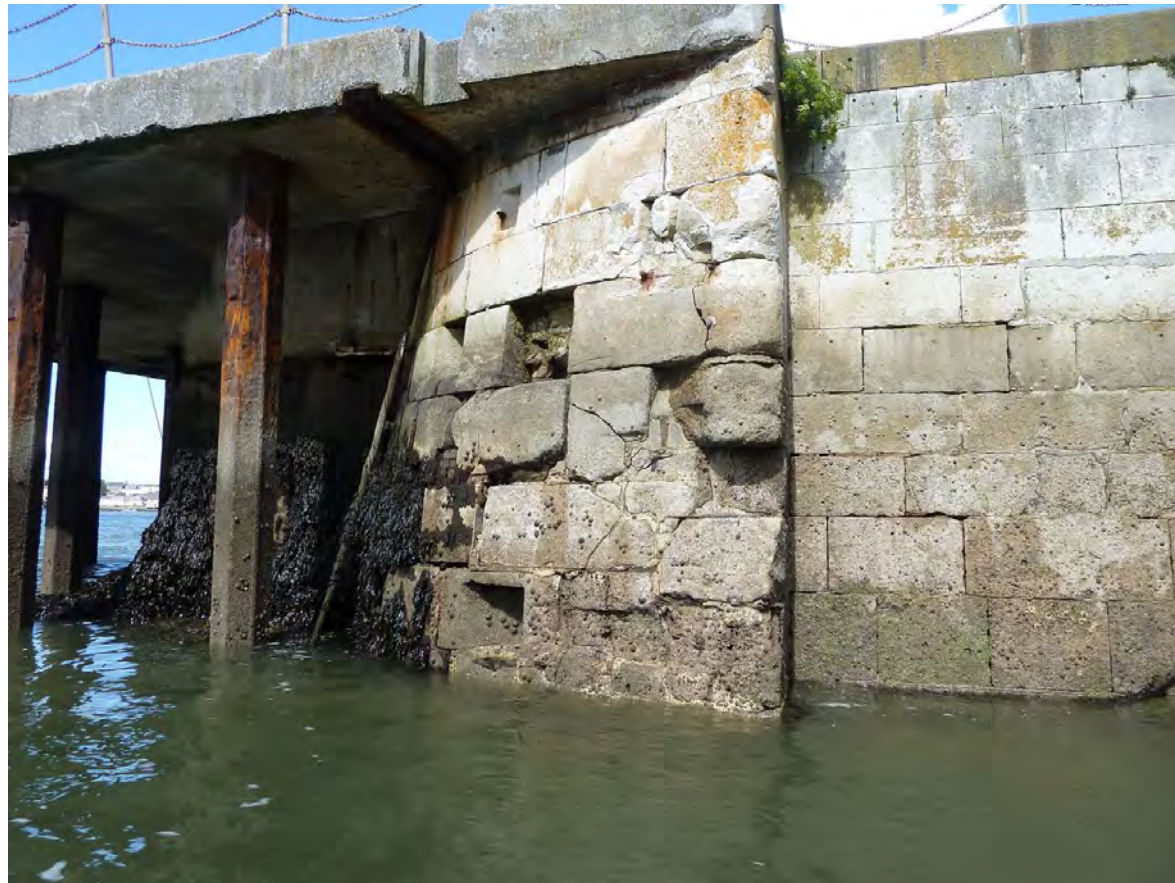
Damaged Blockwork: Damage was nominally noted around the entrance to the dock, none of which appeared of structural concern. Recommend to monitor deterioration.

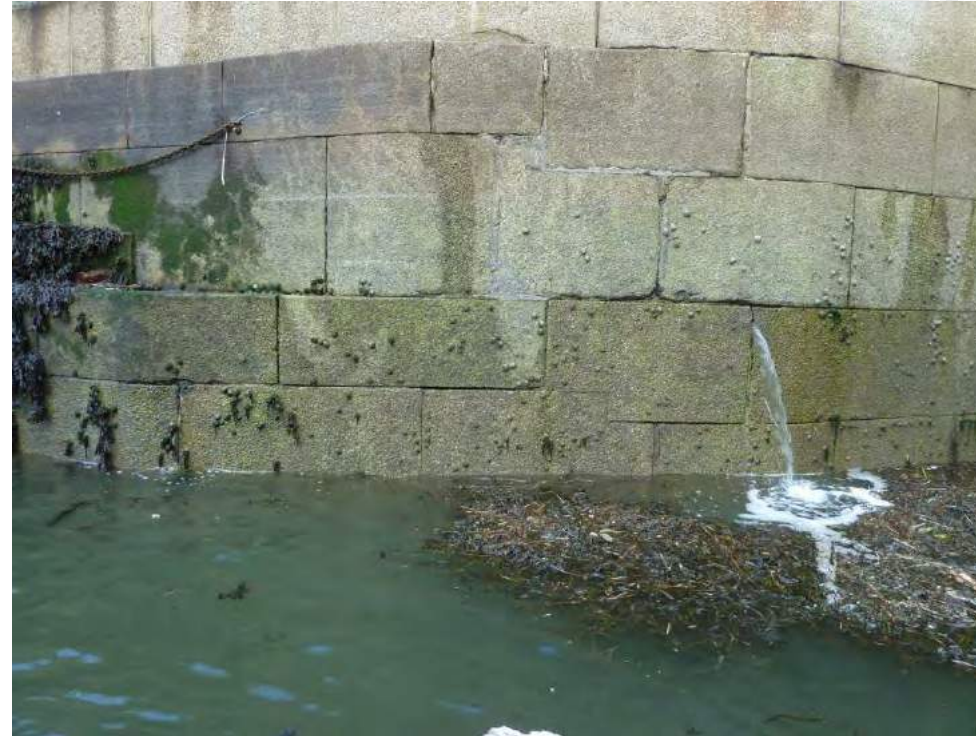
Marine Growth: Removal of marine growth is an ongoing maintenance issue particularly in Dock 4. Cost to remove approx £5,000.

Water Seepage: To repair areas where water seepage is recorded through the mortar, a quick setting water proof product such as Vandex Plug could be applied. To reduce the amount of water through the blockwork a waterproof sealant can be brushed on to the exposed blockwork faces. Cost approx £5,000-£10,000.

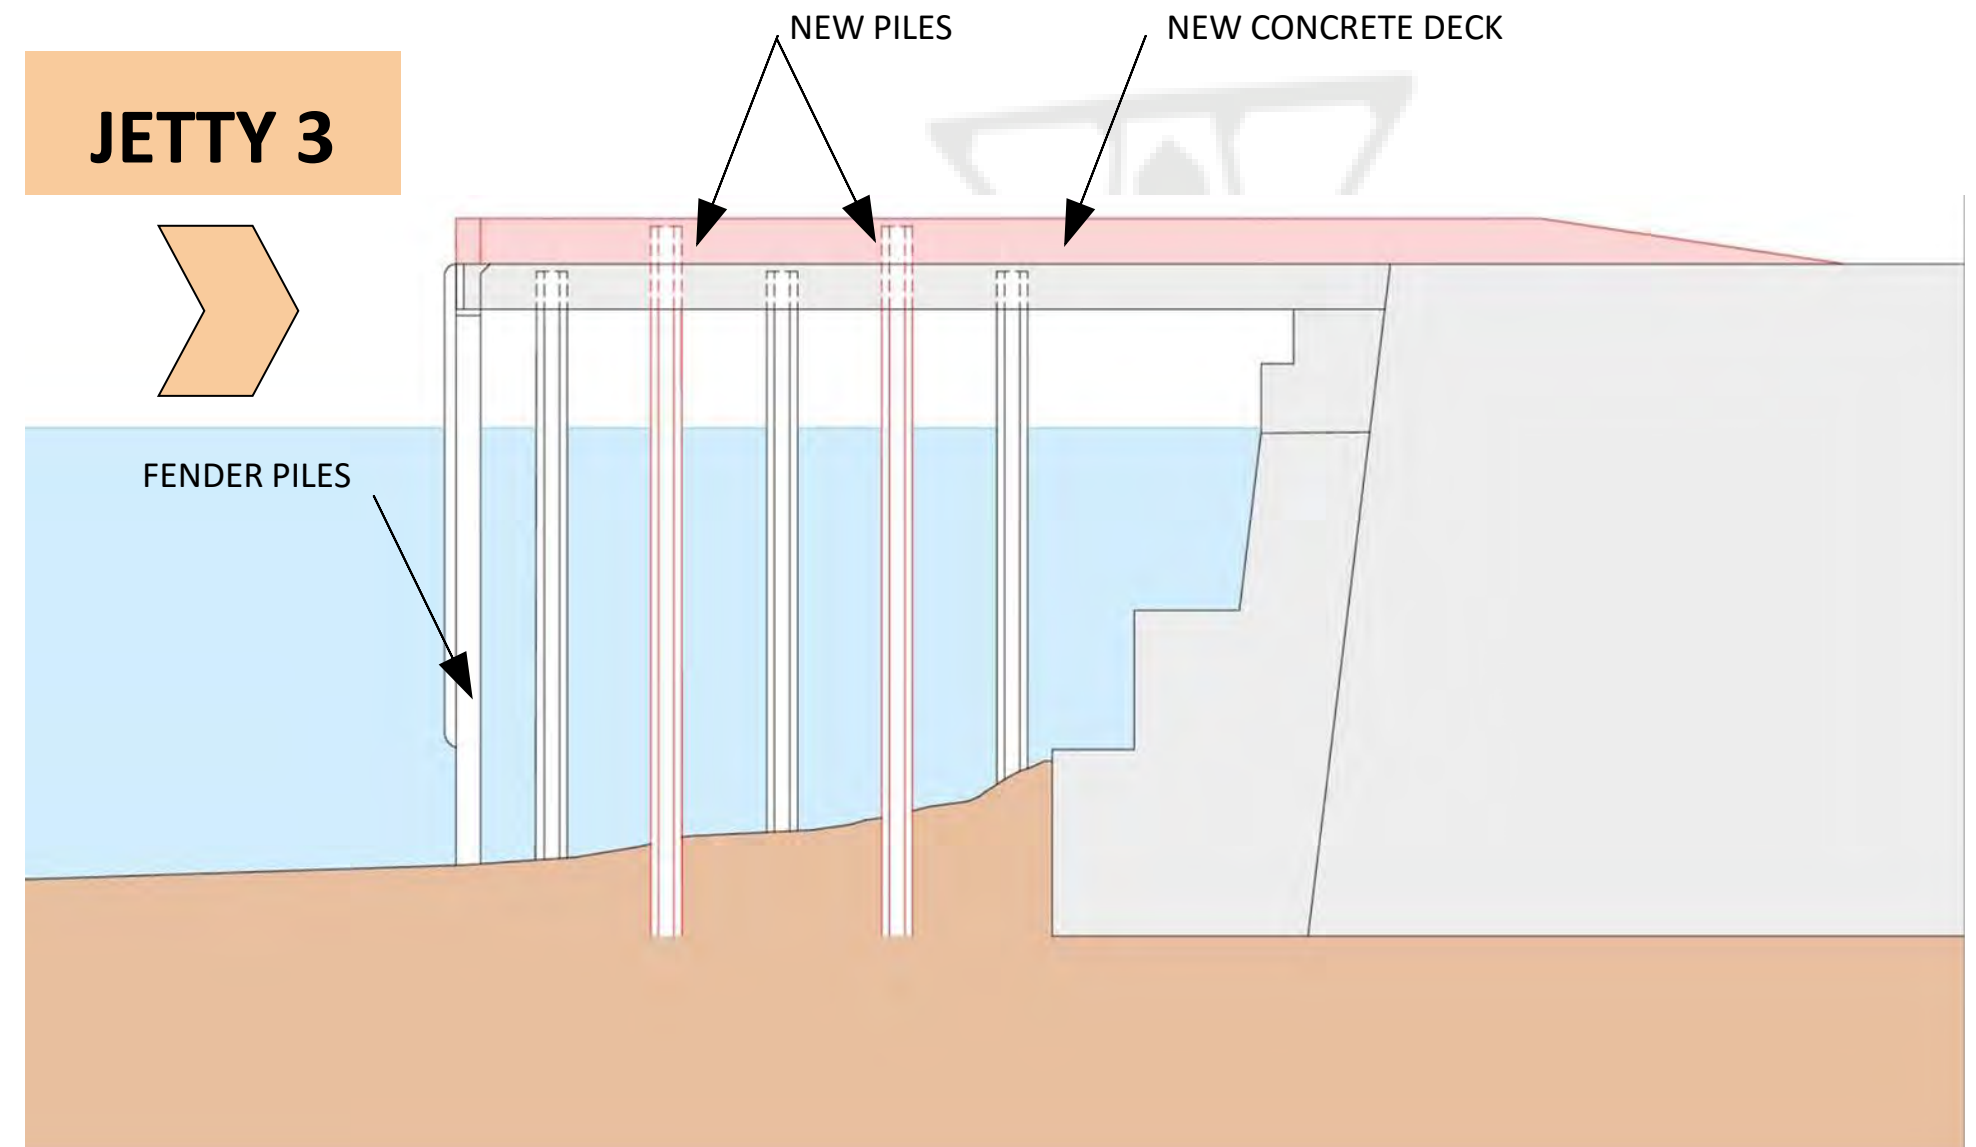
Owing to its poor condition, Jetty 3 it is unlikely to be suitable for future. For the redevelopment of Jetty 3, a solution may be in the form of a new concrete deck supported by new steel piles. The old fender piles will also need to be replaced. This procedure could be more cost and time effective in comparison with refurbishment or integrating new piles into the existing deck (due to the number of piles).

A high level cost estimate for such works would be in the order of £1.5 -£2 million.
